Hard Lodging; Solomon's Folly

CARR-90

historic Rock Hall; Solomon's Folly

and/or common Hard Lodging

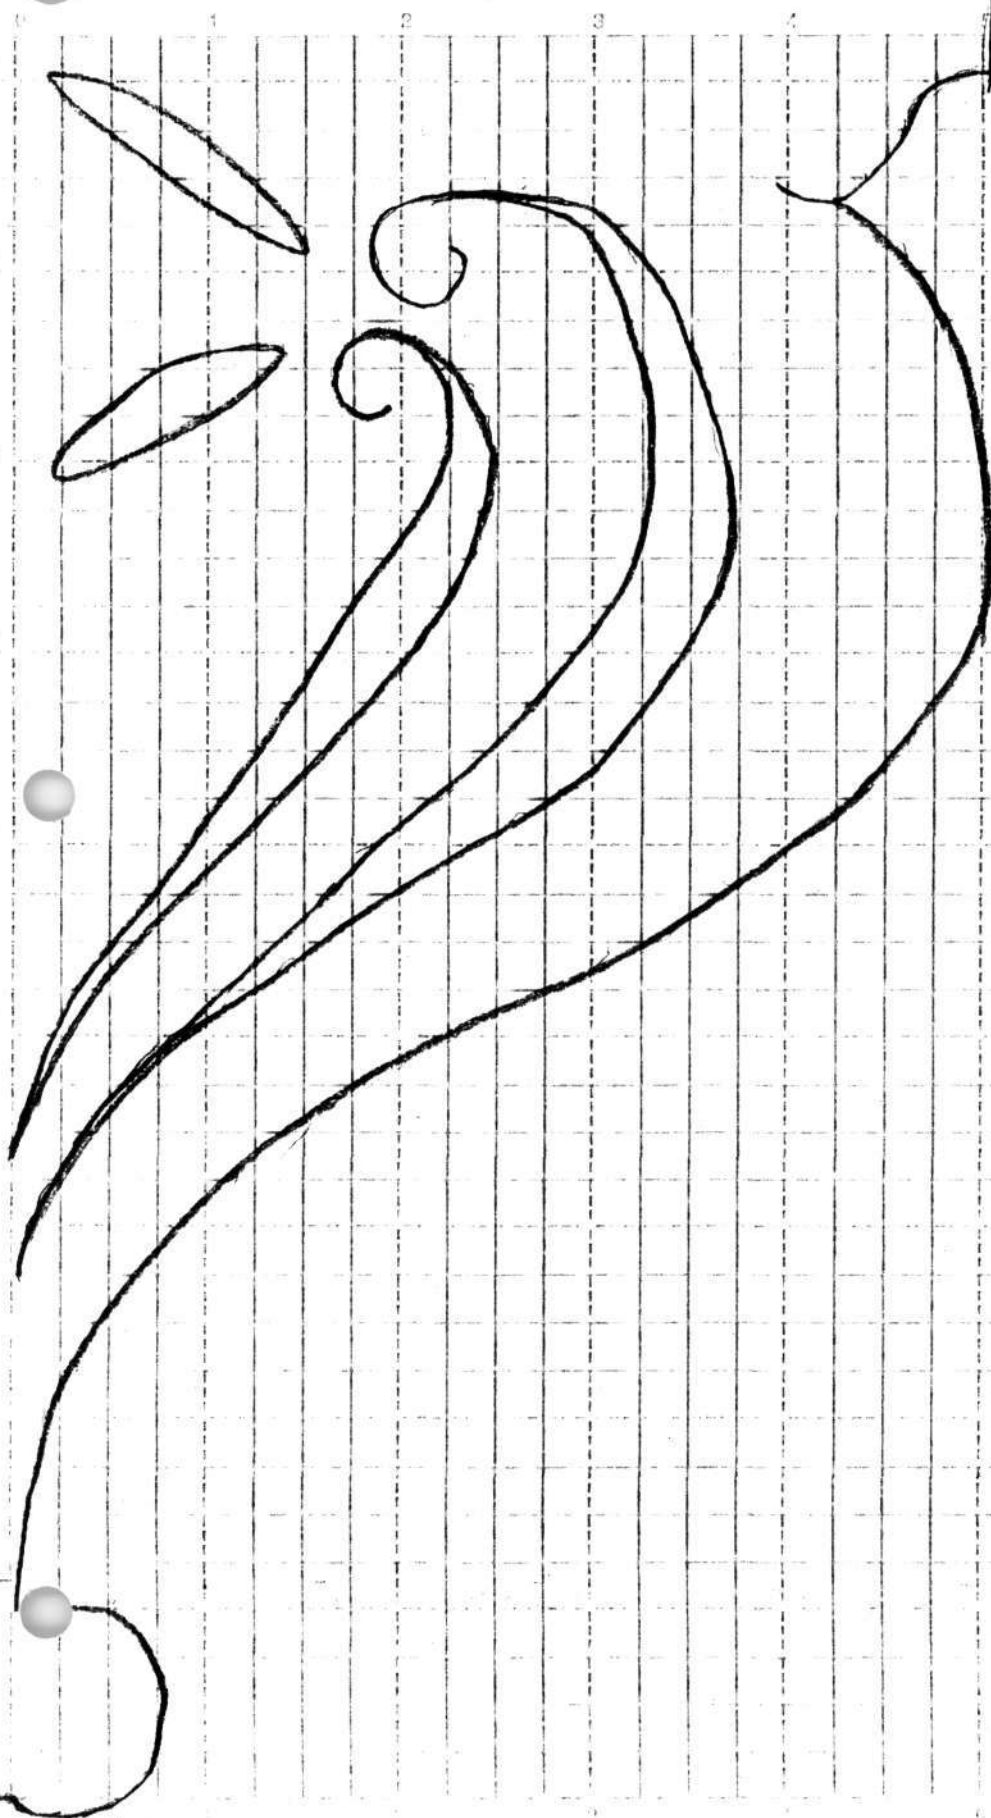
2/5

Hard Lodging
Stair Bracket

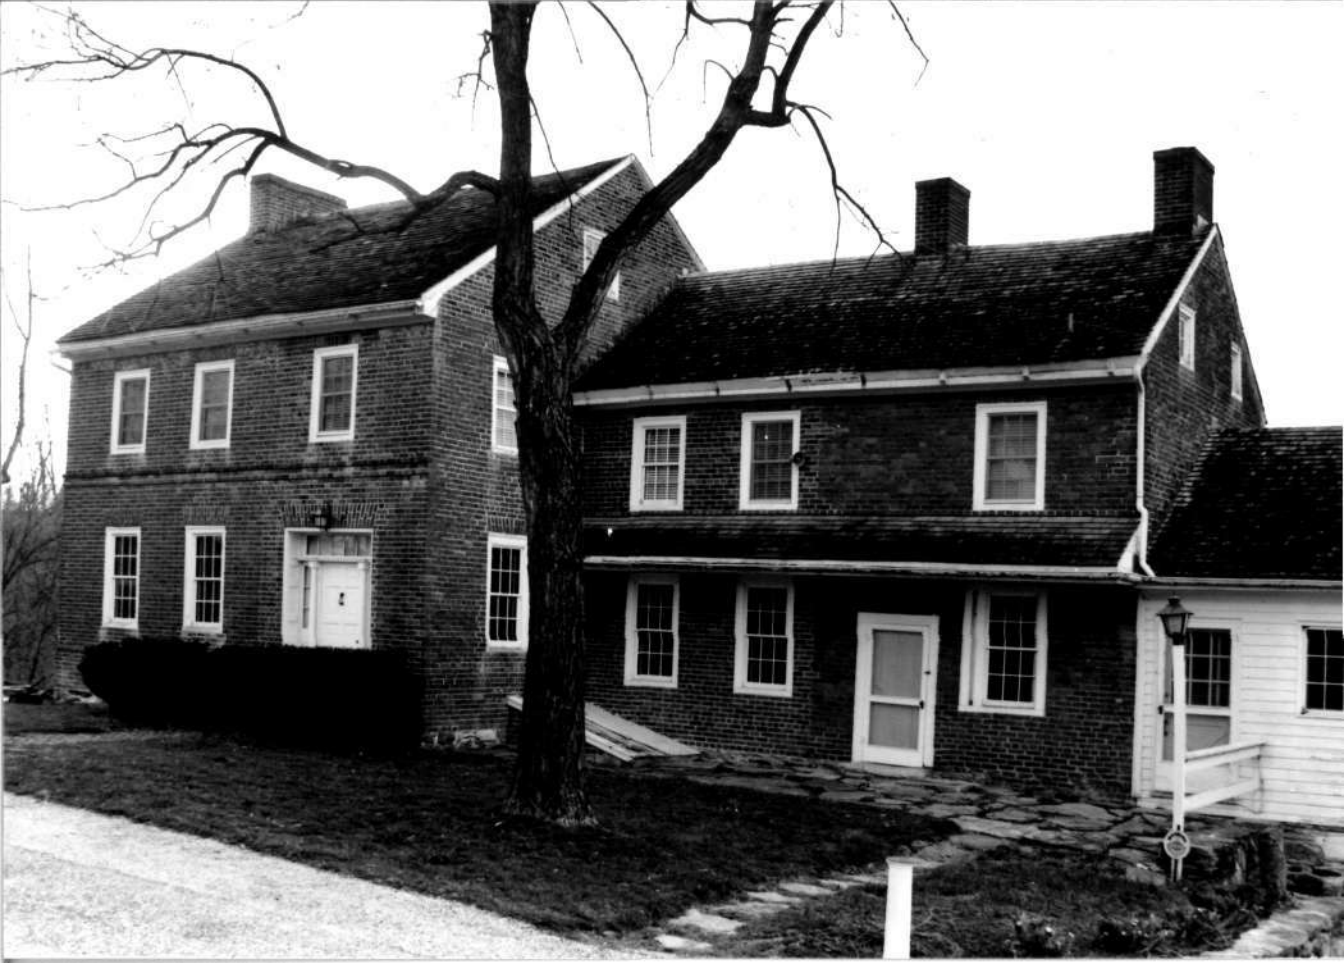
"Hard Lodging"
4623 Ladiesburg Rd.
Carroll County, Maryland
Photo: Kenneth M. Short
Date: March 1995
Neg. loc.: Maryland Historical Trust
South elev.
1/13

The south elevation of the main block of "Hard Lodging" has a raised basement with

a moulded water table. In the foundation, the west bay has a segmentally-arched opening with an eight-light sash set behind horizontal diamond-in-section wood louvers in a beaded-interior-edge frame. The first-story west bay has a 6/6 double-hung sash in a mortised-and-tenoned-and-pegged frame. There are pegs both at the lintels and in the sills, and the frame has an ovolo backband that is wirenailed. The sill is wood, and there is a splayed-brick jack arch. Holes in the frame for pintles have now been filled, as have mortises for shutter hinges. The center bay has the same 6/6 sash, but with no pegs in the sill. The east bay has an eight-panel door with sunk fields and quirked ogee panel moulds. The door has small panels at the top, then larger square panels below, with small panels below them, and larger square panels at the bottom. The door is flanked by a column on either side, with a Greek ovolo capital. The transom bar has a Greek cavetto. There are sidelights with three lights over one panel. The panels have sunk fields with ogee and cavetto panel moulds on each side. The transom has six lights. The jambs have four panels below the transom bar; these are flat and sunk with the same mouldings as found on the door. They line up pretty close to those on the door, but are not exact. The sidelights and panel below do not line up at all with the panels on the jambs. The door frame is mortised and tenoned and pegged. The transom bar cuts off the bottom of the jamb panel at the transom level as if it was added later. The soffit has one panel identical to those in the jambs. The door frame has a large bead that resembles more closely a quirked bullnose. The doorway has a splayed-brick jack arch and a stone sill that appears to be granite. The sill is cut without a weather. Between the first and second stories is a belt course consisting of three brick courses. The bottom course is corbelled, and the top course is corbelled again. The middle course is in the same plane as the bottom course. The second story has three 6/6 sash that are shorter than those in the first story, but otherwise match the first-story, west-bay windows. There is a wood box cornice and an interior brick chimney.

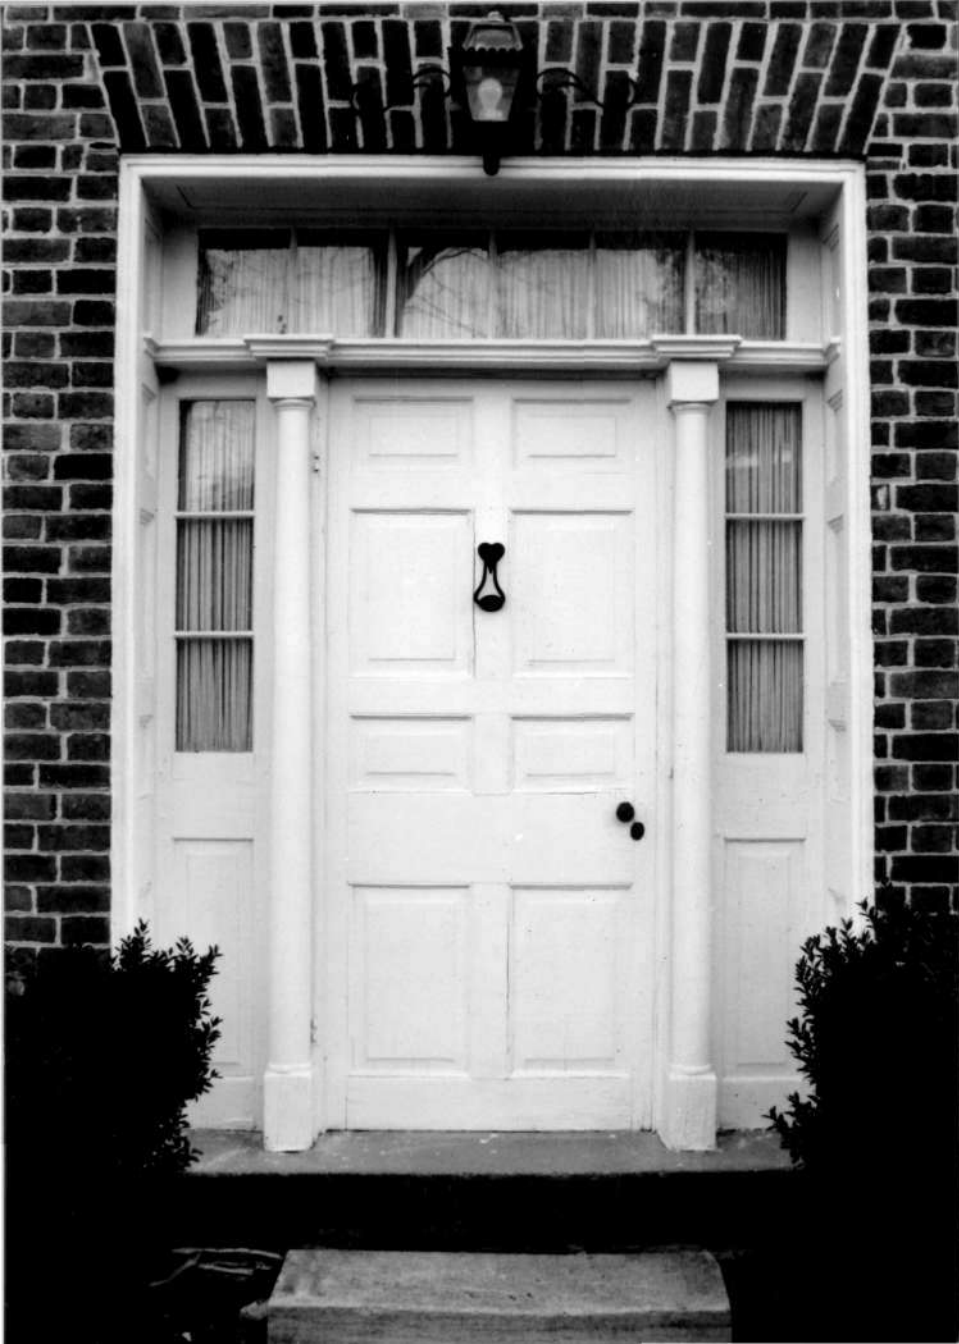
2/13

South elev. - front door

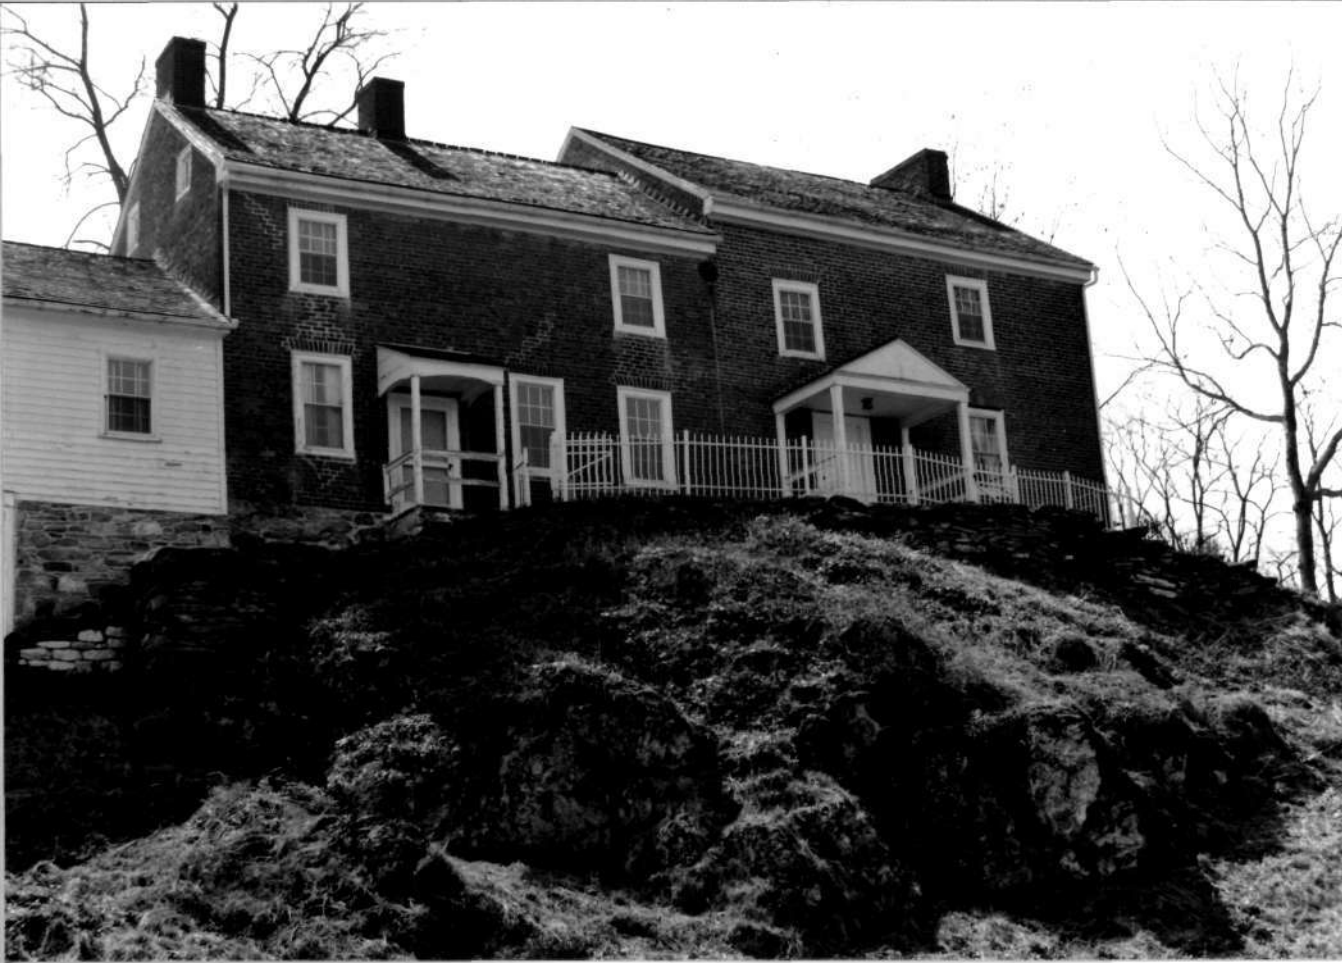
5/13

N. : E. elevs.

The north elevation is two bays. In the foundation the west bay has a segmentally-arched opening with a three-light sash set behind horizontal diamond-in-section wood louvers. It has a wood sill and a beaded-interior-edge frame. On the first story, the east bay has a six-panel door with sunk fields and ogee panel moulds. The mortised-and-tenoned-and-

On the north elevation of the wing there is no break in the rubble stone foundation, but there is a break in the brick between the wing and the main block. The foundation continues east of the east wall of this wing by about nine feet and it steps down slightly. This extension to the foundation is now covered by part of the large German-sided addition on the east. The first-story east bay has a 6/6 double-hung sash in a mortised-and-tenoned-

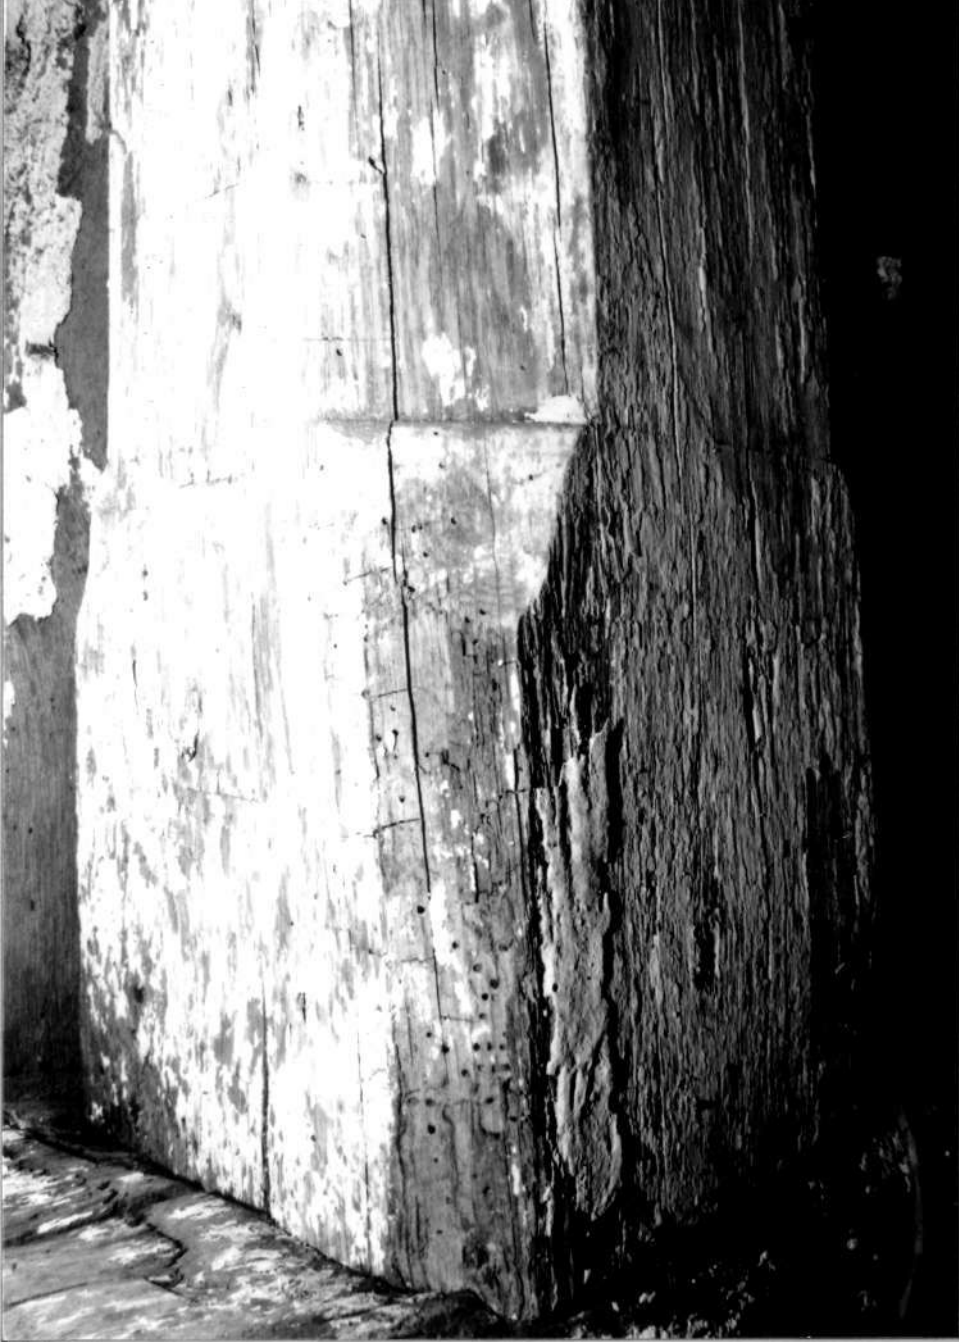
6/13

Neg. loc.: Maryland Historical Trust
cellar post

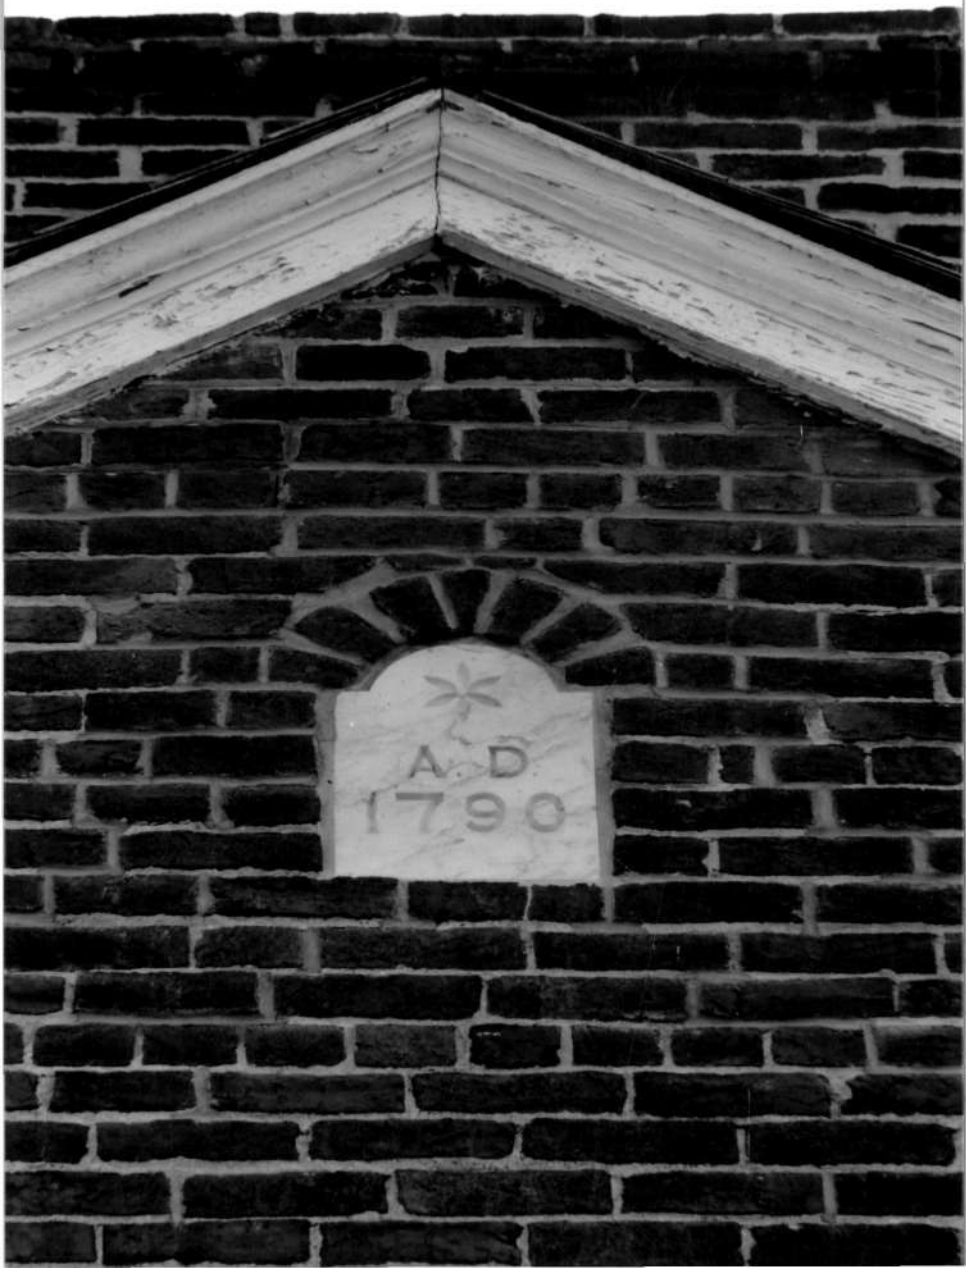
3/13

A.D.
1790

w. elev. datestone

A date stone in the gable end of this structure is inscribed "1790." The south and west facades are Flemish bond with a molded watertable. The other walls are laid in common bond. Again, the first story windows are taller than those on the second floor, and they have gauged flat-arch brick lintels, while the second floor flat-arch lintels consist of single bricks. A three-brick-high belt course exists between the two floors on the south facade. This facade also contains the main entranceway, an eight-panel door flanked by slender side columns, three-pane sidelights, a six-light transom and a paneled recess. The north facade has a window to light the staircase directly above a small entranceway porch and single six-over-six windows on each floor.

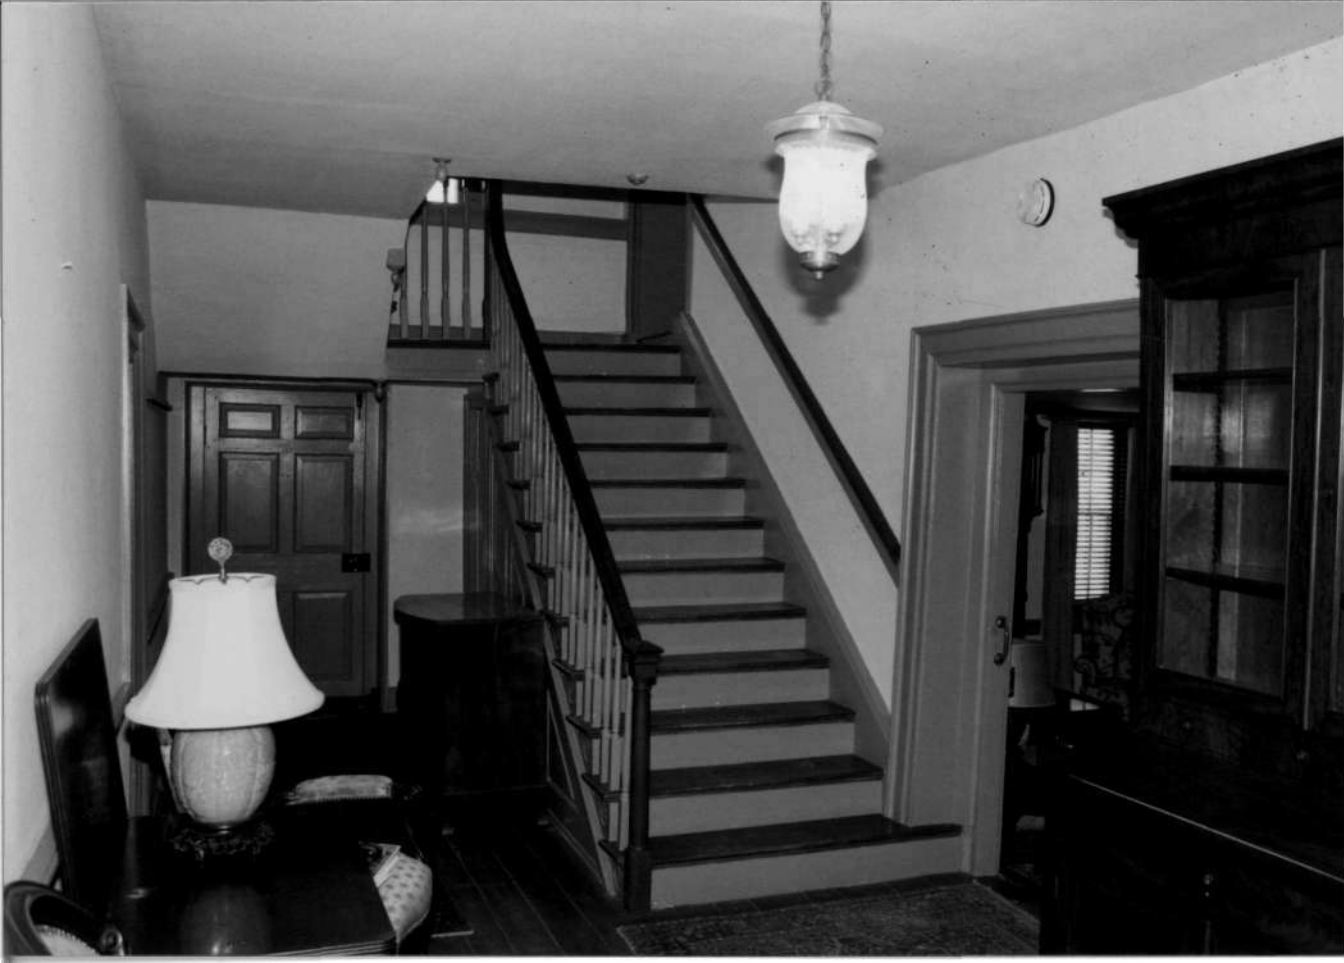
7/13

Neg. loc.: Maryland Historical Trust
passage-view north

The first story has a side-passage, double-pile plan with a two room addition on the east. The passage has an oak floor that runs north-south and is face-nailed with what appear to be cut nails. The floor is random width between 5 and 7 inches. The baseboard has a beaded top edge. The architrave has an ovolo backband, a broken field with an ogee at the break, and a beaded interior edge. The passage has a chair rail with an ovolo on the edge of the shelf, and a cavetto and bead below it, with a bead at the bottom edge of the chair rail. The six-panel doors have raised fields and ovolo panel moulds. They have plain cast iron rim locks with pressed metal knobs and replacement butt hinges. The reverse sides of the doors have flat, sunk panels with no moulds. The window jamb has an ovolo on the inner edge with no architrave. The inset frame is plain. The front door has sunk fields with ogee panel moulds. The architrave has a quirked ogee backband, a broken field with an ogee at the break, and a beaded interior edge. The door has a carpenter lock with a brass seal that is marked "Carpenter & C^o Patentees." The sidelights have one panel below, with a sunk field and no panel mould. The rear, or north, door jamb has an ovolo mould on the inner edge. The door frame has a beaded interior edge, and the door has sunk fields with ogee panel moulds. There is a carpenter lock identical to that on the front door. There is an open stringer, dog-leg stair on the east wall, with a landing at the north end. It has sawn brackets with a "rabbit-ear" pattern and panels beneath the stringer that have raised fields and ovolo panel moulds. There are turned balusters and a moulded hand rail. The bottom ends of the newel posts have pendant drops. There is a typical door under the stair that leads to the cellar. This door has a reproduction latch. The architrave has an ovolo backband and a beaded interior edge. There is a doorway on the east elevation at the foot of the stairs that leads to the addition. It is unusually wide, but has the same architrave as the rest of the doors. It also has an inset frame, with an ovolo at the break, and a beaded interior edge. The door is identical to the rest of the doors in the passage. There is a peg rail on the west wall, to the north, that has a bead on the top and bottom edges. There is a new built-in corner cupboard on the southeast corner of the passage.

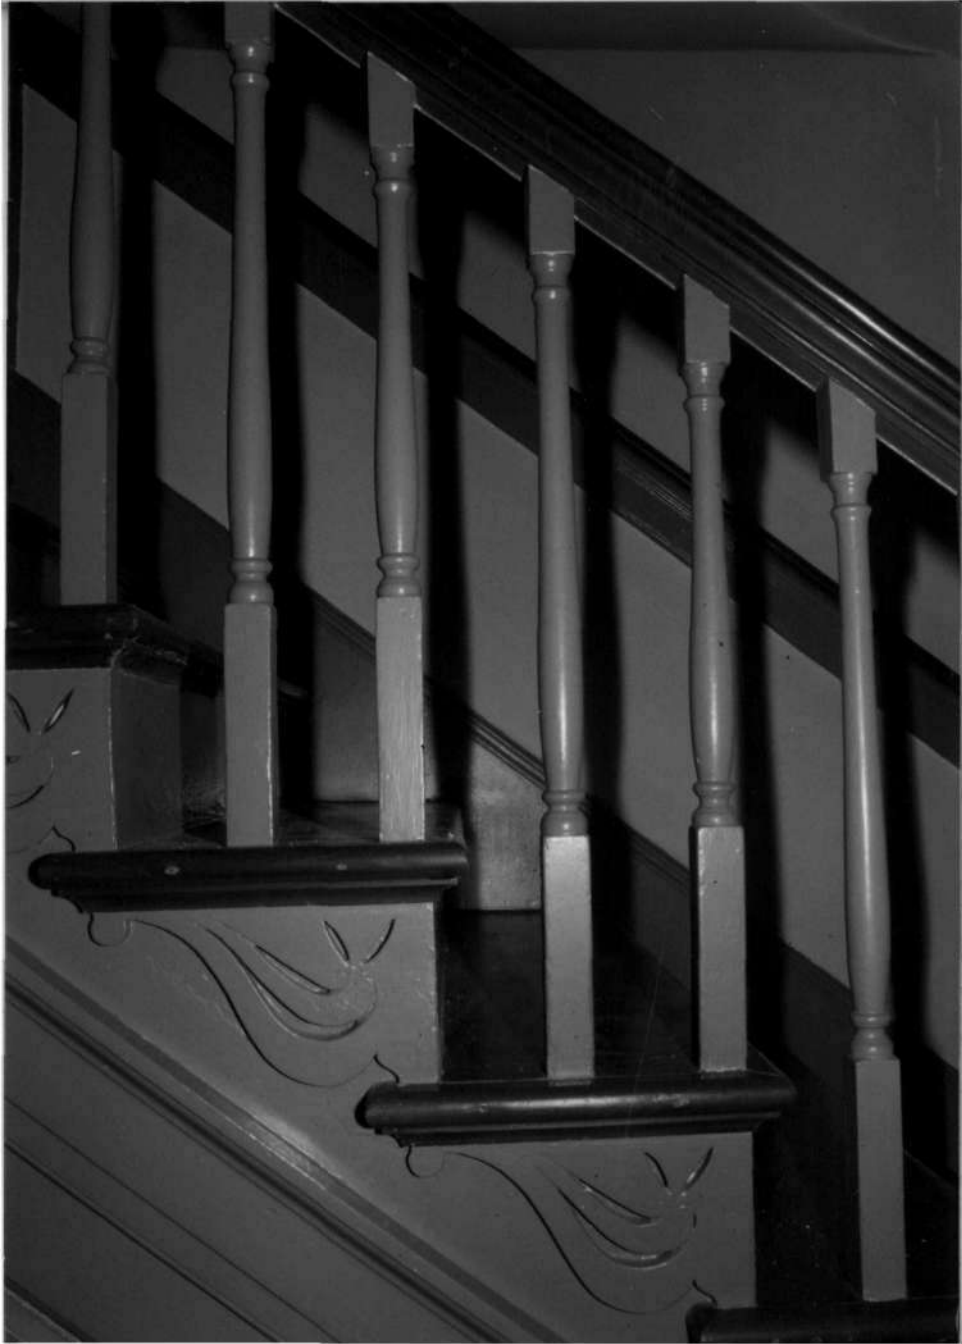
8/13

Neg. Loc.: Maryland Historical Trust
stair detail

The side entrance plan provides a cross passageway that contains the staircase and two rooms to the west of the passageway. The staircase has an ovoid handrail, turned balusters, scroll with a flower motif, stair ends, and angular paneling below. The woodwork in this passageway and the adjoining rooms -- chairrails, cornice moldings, and mantelpieces -- is of Federal design.

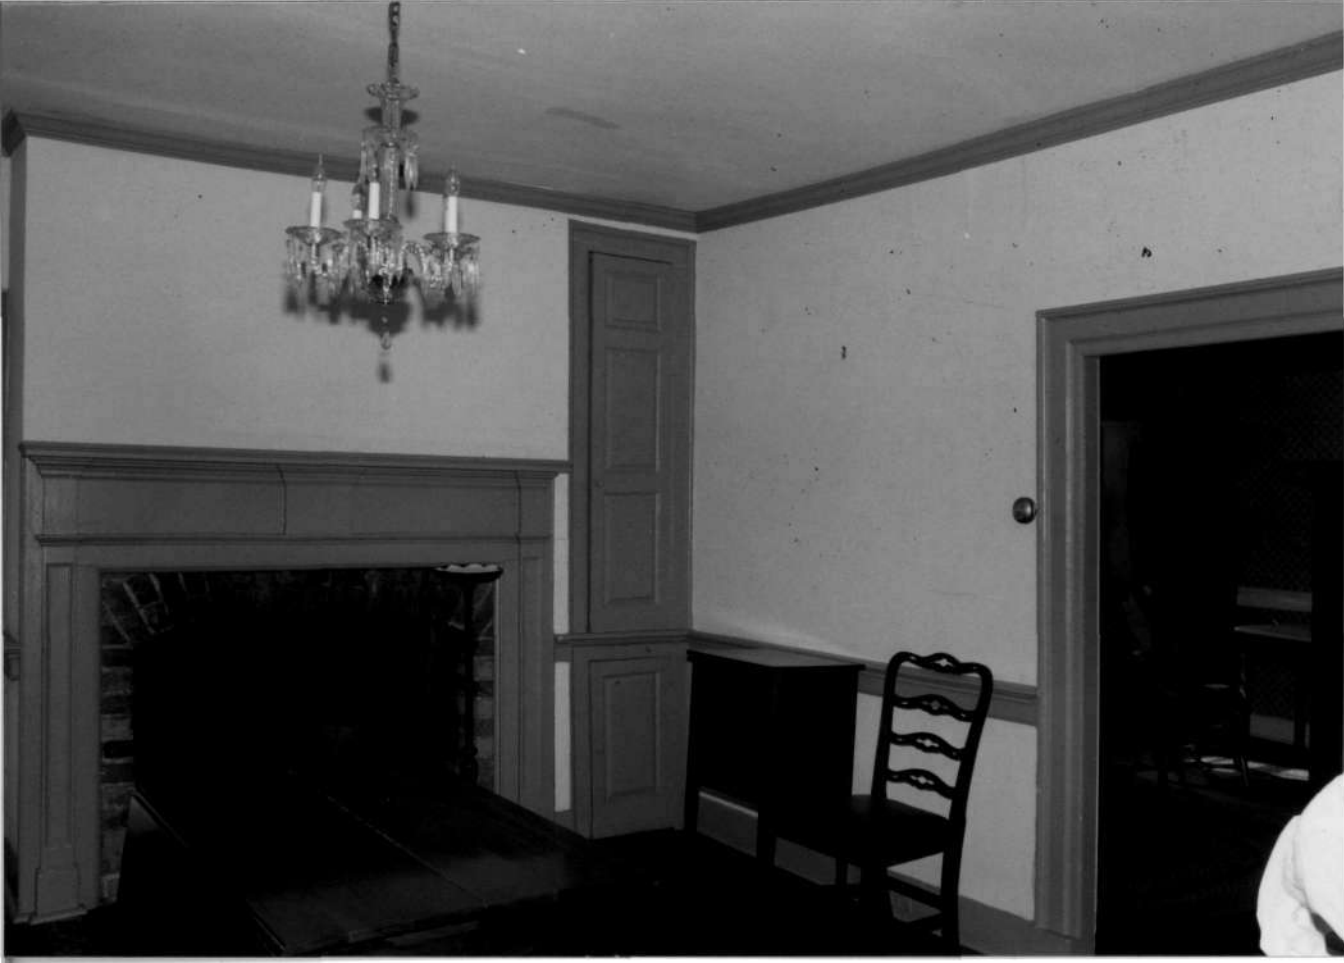
10/13

Neg. Loc.: Maryland Historical Trust
SW room mantel & cupboard

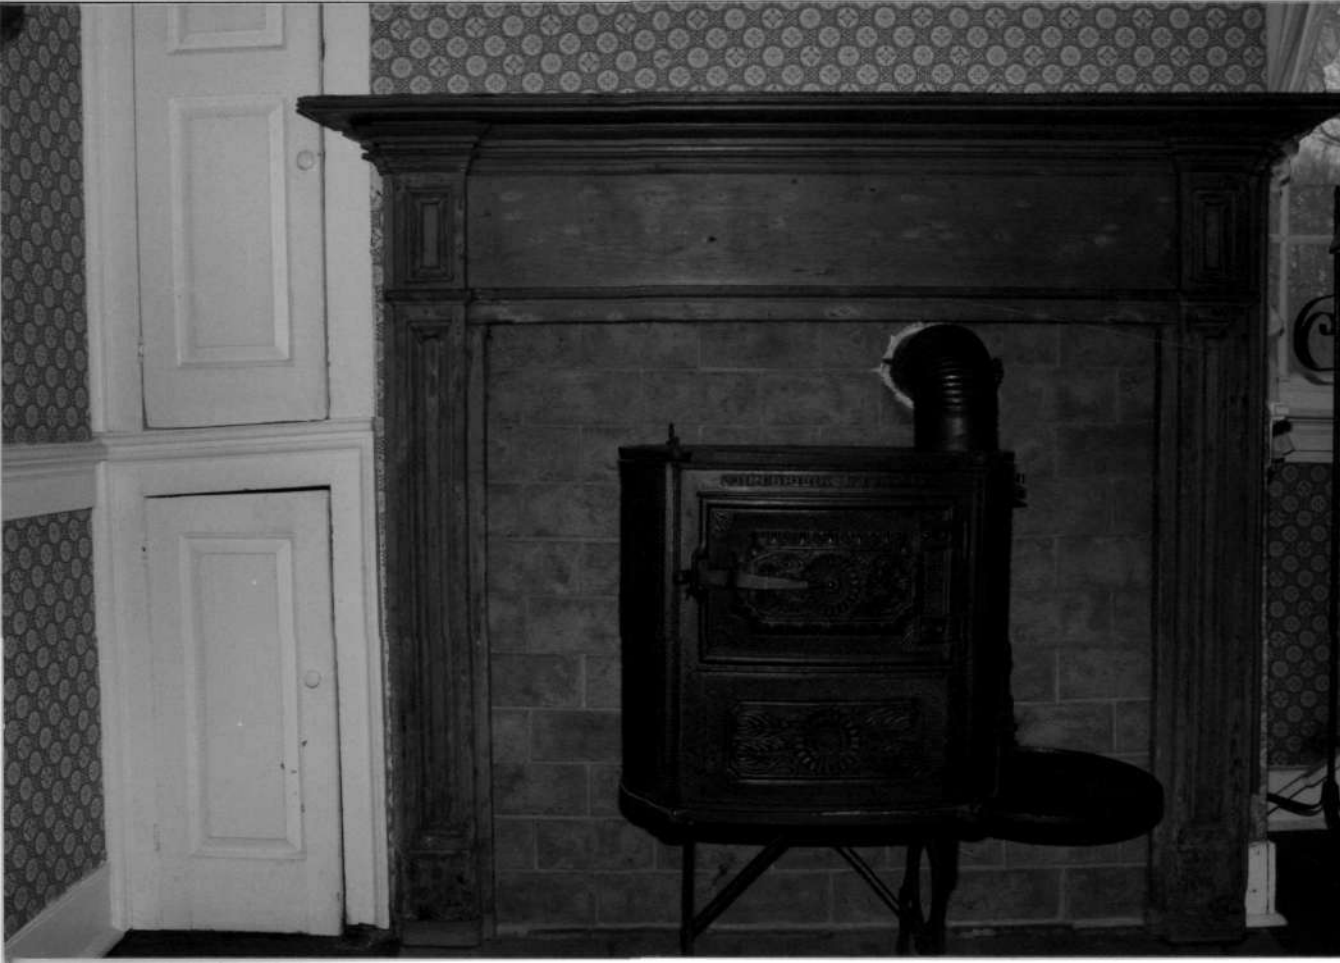
11/13

NW room mantel

The northwest room floor has mostly been replaced with 3 $\frac{3}{8}$ -inch-wide pine. It has typical baseboard and a chair rail identical to the passage. The door architraves are identical to the southwest room east door. Under the west window the sill and trim is cut out to make a small drawer that is dovetailed on the sides. There is a fireplace on the west wall that is closed off. The mantel appears to be later and may have been moved here recently; it may not even be part of the house. It has paneled pilasters with beads inside, and the bed mould has an ovolo, cavetto and bead. There is a cupboard to the south that is identical to the cupboard in the southwest room, but part of the backband is missing. The interior of this cupboard is original. This room has now been converted to a modern kitchen.

The mantel in the northwest room appears to have been moved here, probably from another building. The mantel in the 1950's addition appears to have come from the northwest room. The wing is rather problematic. The foundation appears to have been built for both halves of the house at once, but the brick wall on the rear elevation is clearly broken, and there is a foundation window on the east elevation of the main block that has been closed off where the wing attaches and covers it. The doorway to the wing, and the finishes in it, appear to be identical to those found in the main block. There are numerous scenarios that might explain this, including changes in building plans, delayed completion of the construction, and later alterations to much of the house. Unfortunately, too little information exists on the building to be more definitive. More exploration of the building fabric is needed.

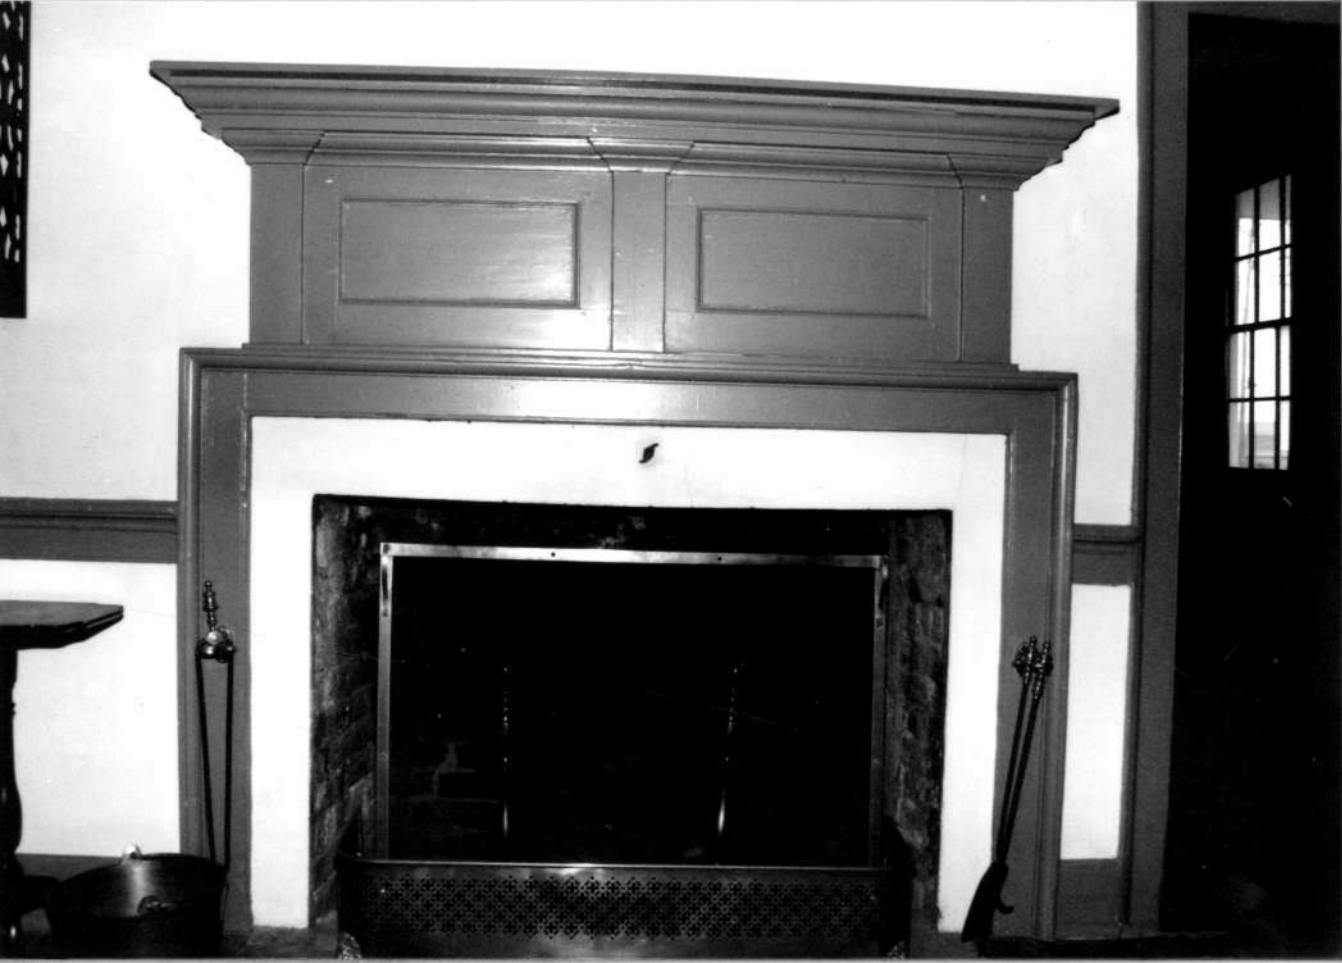
12/13

"Hard Lodging"
4623 Ladiesburg Rd.
Carroll County, Maryland
Photo: Kenneth M. Short
Date: March 1995
Neg. Loc.: Maryland Historical Trust
ell west room mantel

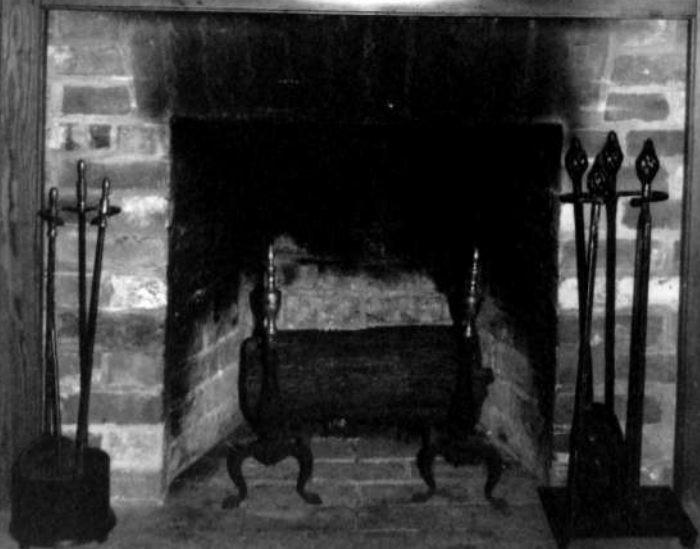
13/13

Addition mantel
